# **COMPREHENSIVE MOTOR VEHICLE SERVICES & CONSULTING Motor Vehicle Forensic Analysis Report**

**People of the State of New York v.**  
**Nauman Hussain**

CMVSC-18-VA-253

**REFERENCED INVOLVED SUBJECT VEHICLE:** 2001 Ford Excursion Stretch Limousine,  
VIN 1FMNU40S51EB10299

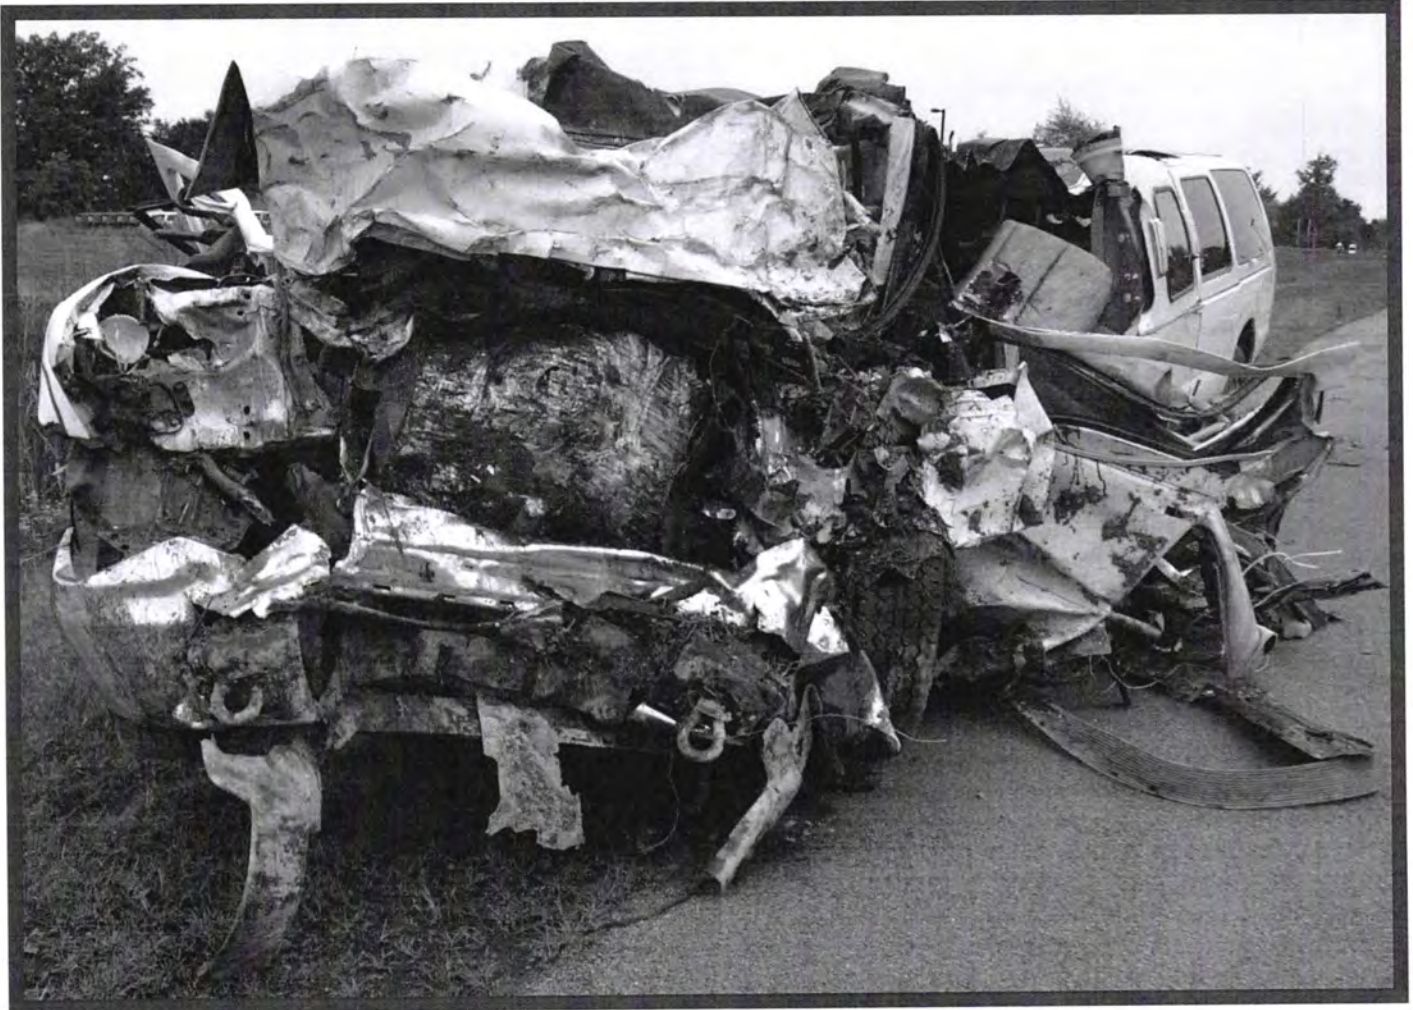
**Image No.4.** This photograph depicts the severity of the frontal structural damage sustained by the 2001 Ford Excursion stretch limousine due to the violent impact forces of the crash. Note that the structural integrity of the vehicle rearward of the B-Pillar -- that of the area of "stretch" alteration -- remains intact.

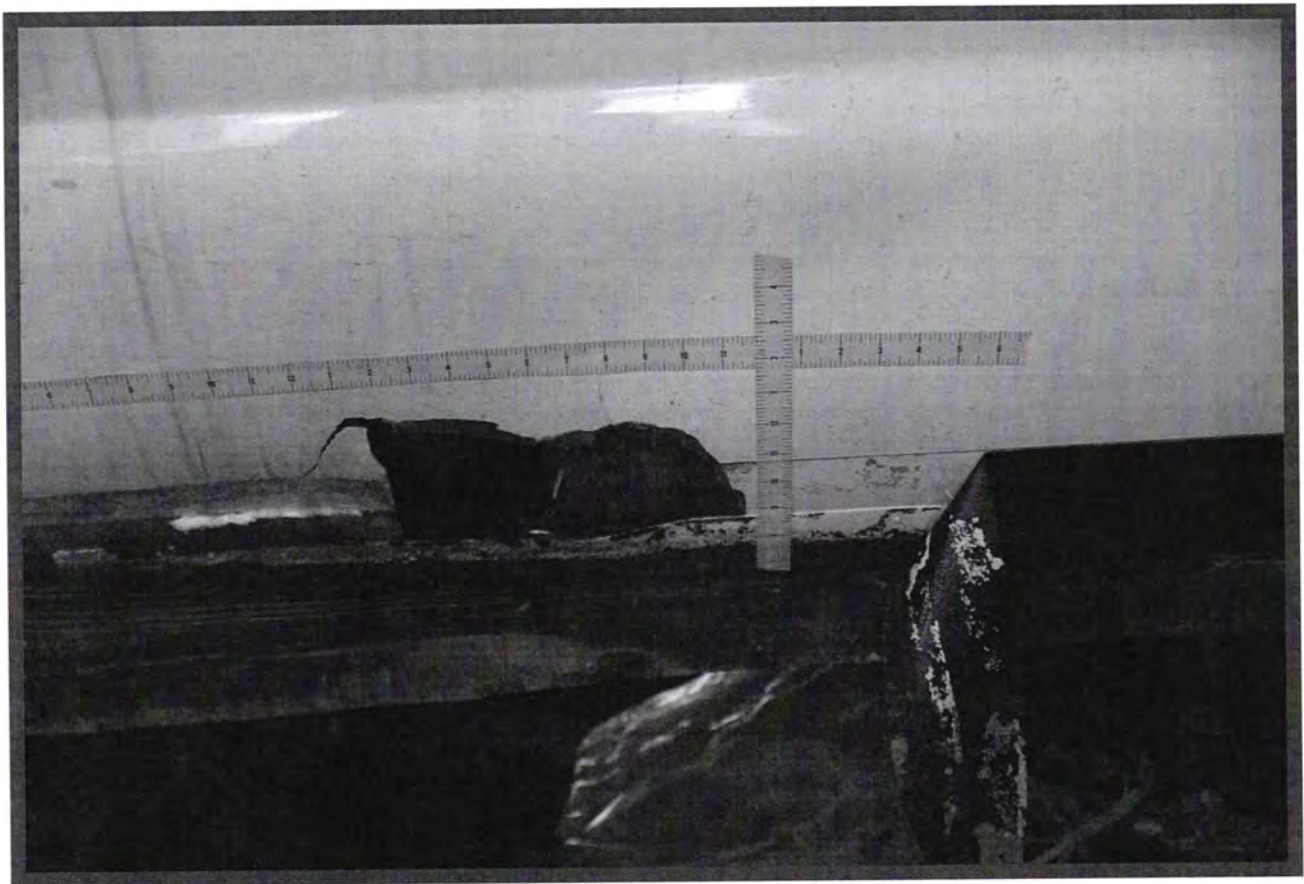
**Image No.5.** This photograph depicts an area of rust-through, located at the left lower side of the 2001 Ford Excursion stretch limousine. This deficiency, which obviously creates a reduction in the integrity of the body panel, as well as allowing for exhaust gases to enter the passenger compartment of the vehicle, reflects that of sustained neglect of mandated vehicle maintenance.

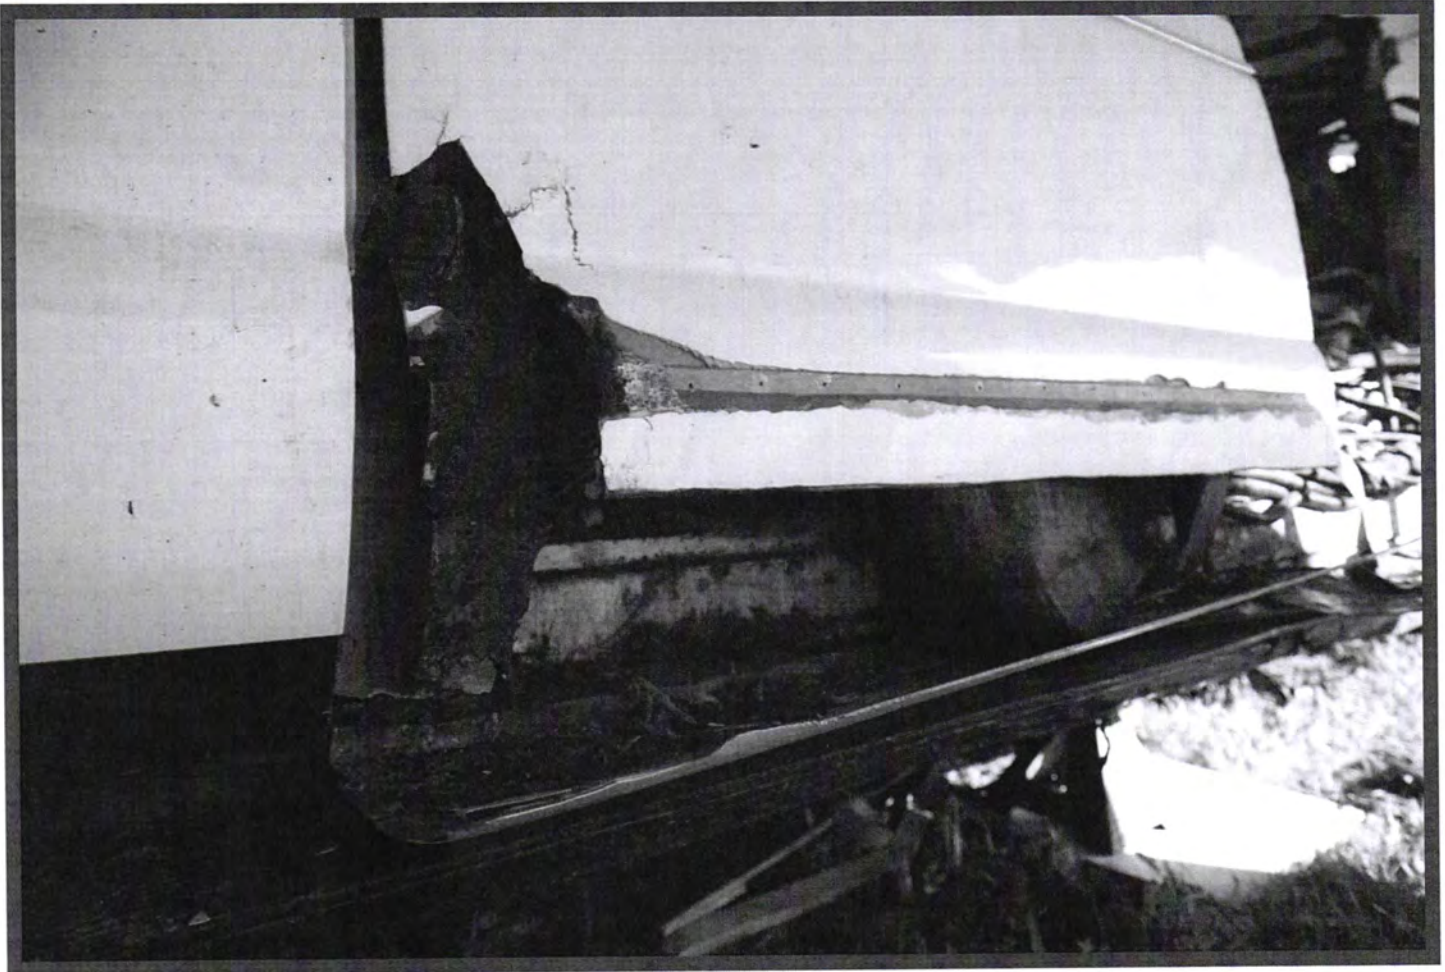
**Image No.6.** This photograph depicts an area of rust-through, located at the right lower side of the 2001 Ford Excursion stretch limousine. This deficiency, which obviously creates a reduction in the integrity of the body panel, as well as allowing for exhaust gases to enter the passenger compartment of the vehicle, also reflects that of sustained neglect of mandated vehicle maintenance.

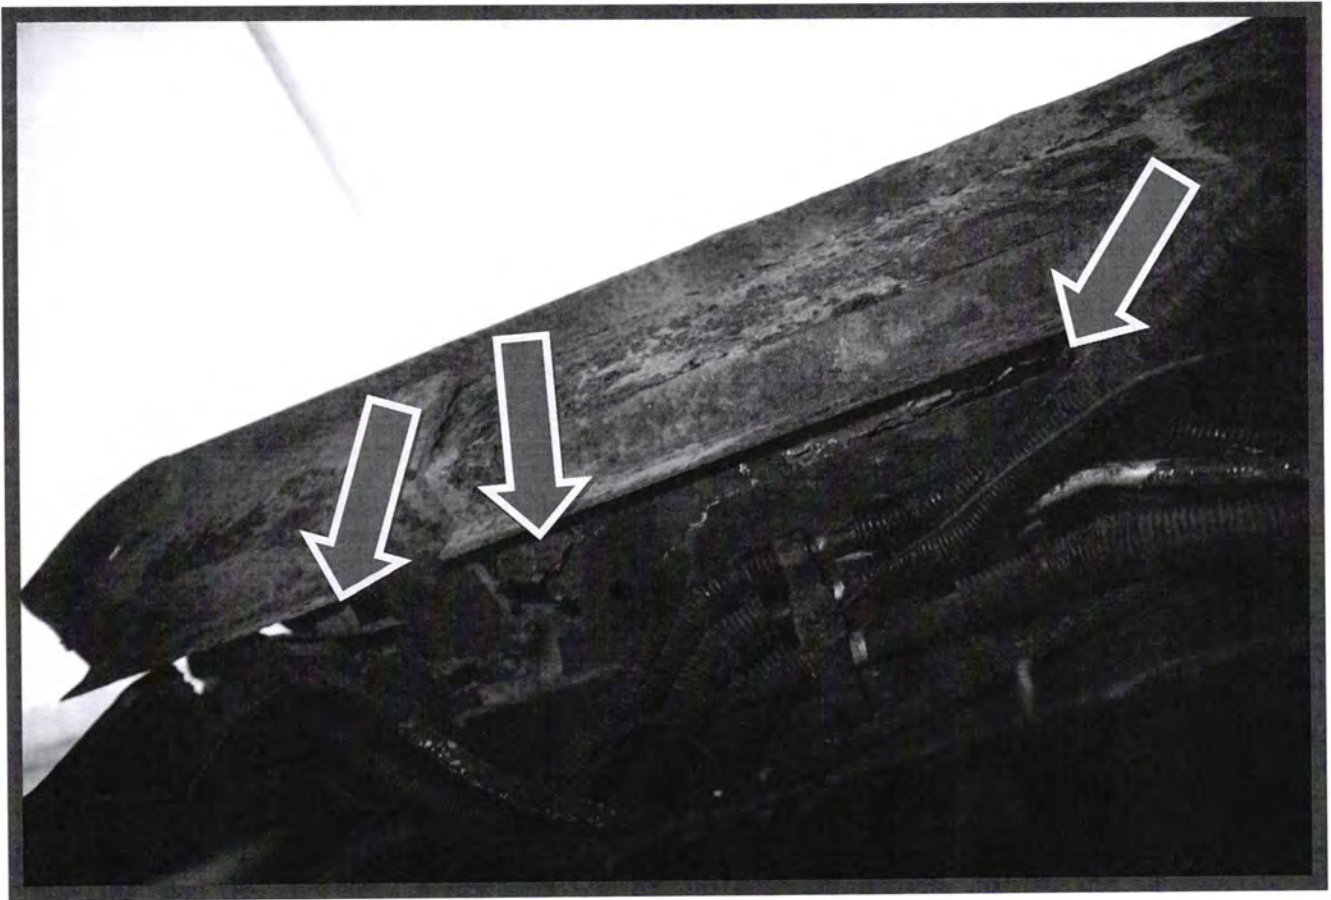
**Image No.7.** The Red Arrows of this photograph depicts areas of rust-through, located at the right rear floor area of the 2001 Ford Excursion stretch limousine. This deficiency, which obviously creates a reduction in the integrity of the floor panel, as well as allowing for exhaust gases to enter the passenger compartment of the vehicle, further reflects that of sustained neglect of mandated vehicle maintenance.

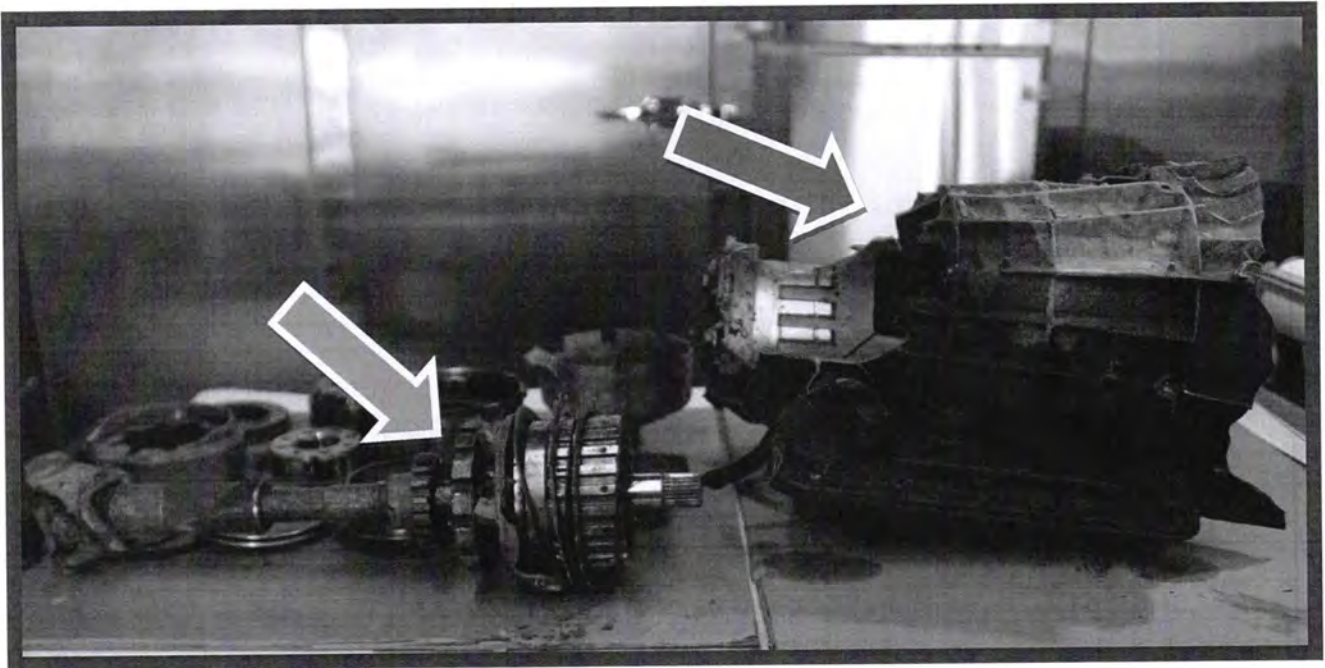
**Image No.8.** This photograph depicts the E4OD/4R100 automatic transmission removed from the involved 2001 Ford Excursion stretch limousine. The Blue Arrow denotes the area of the fractured transmission Main Case, with related Extension Housing separation, as well as Output Shaft (Green Arrow) separation. This substantial damage was the result of the extreme forces associated with crash impact.

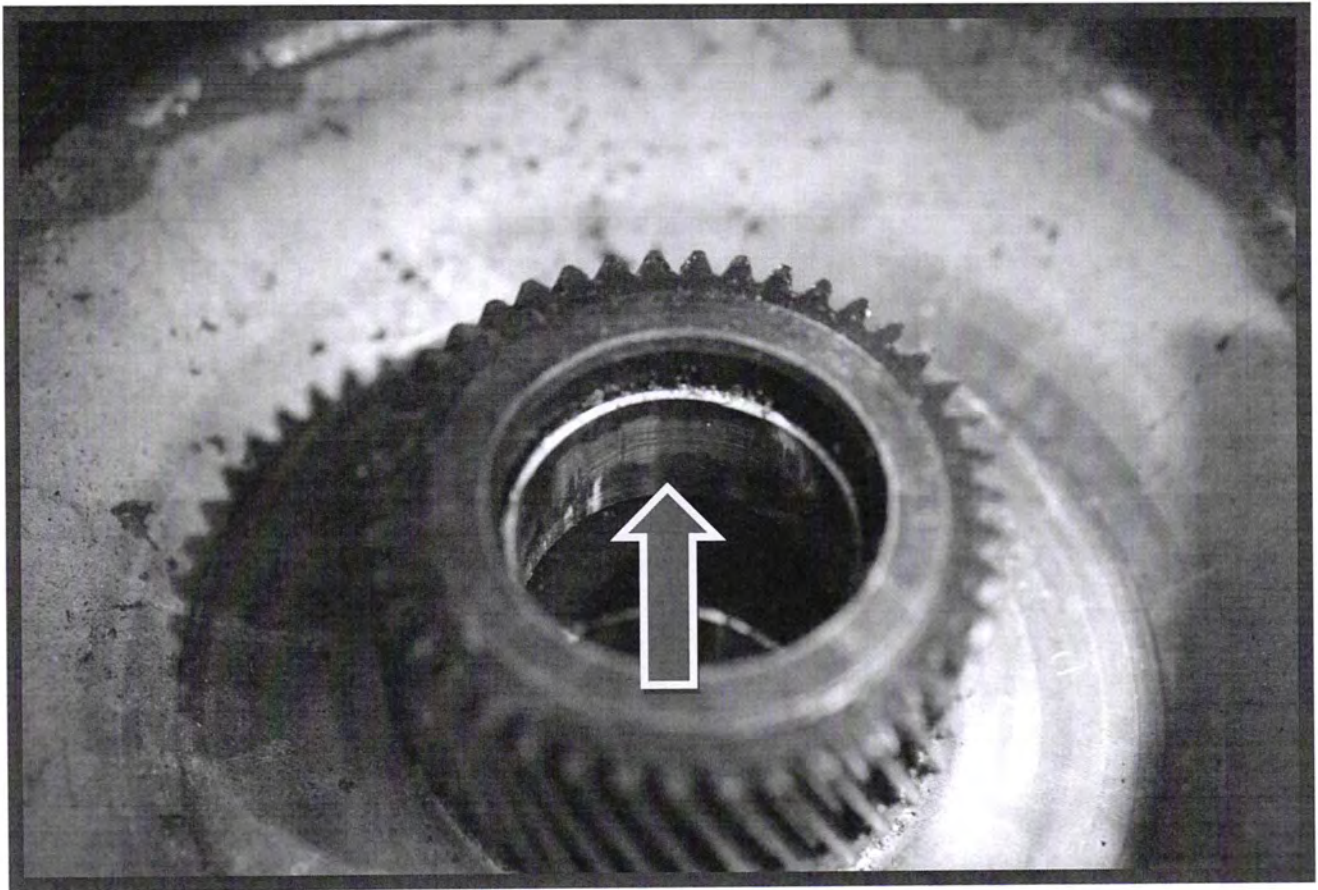
**Image No.9.** This photograph depicts the Forward/Reverse Sun Gear removed from the E4OD/4R100 automatic transmission of the involved 2001 Ford Excursion stretch limousine. The Red Arrow denotes the area of significant bushing wear, consistent with the lack of proper vehicle maintenance.

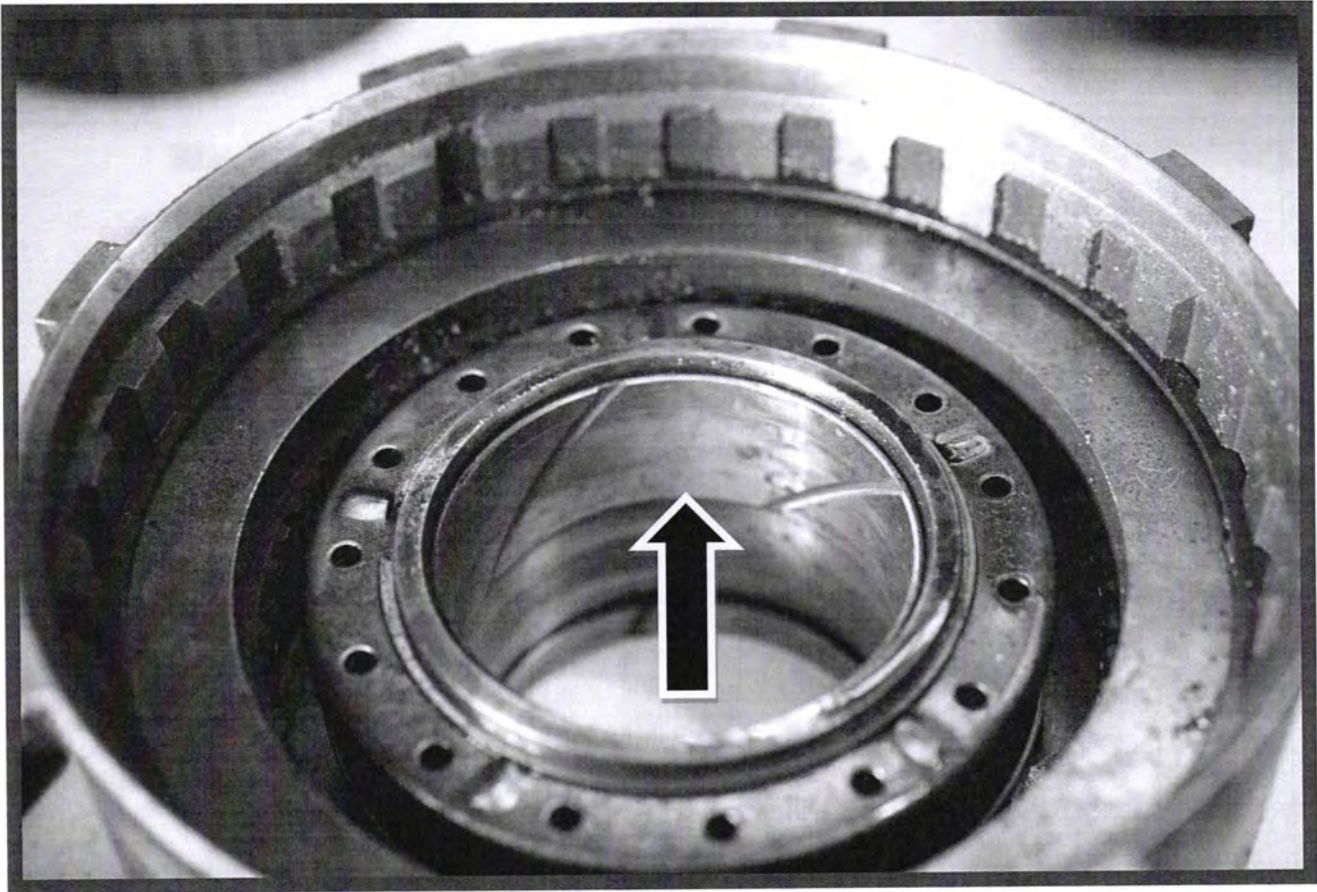
**Image No.10.** This photograph depicts the Direct Drum removed from the E4OD/4R100 automatic transmission of the involved 2001 Ford Excursion stretch limousine. The Black Arrow denotes the area of significant bushing wear, consistent with the lack of proper vehicle maintenance.

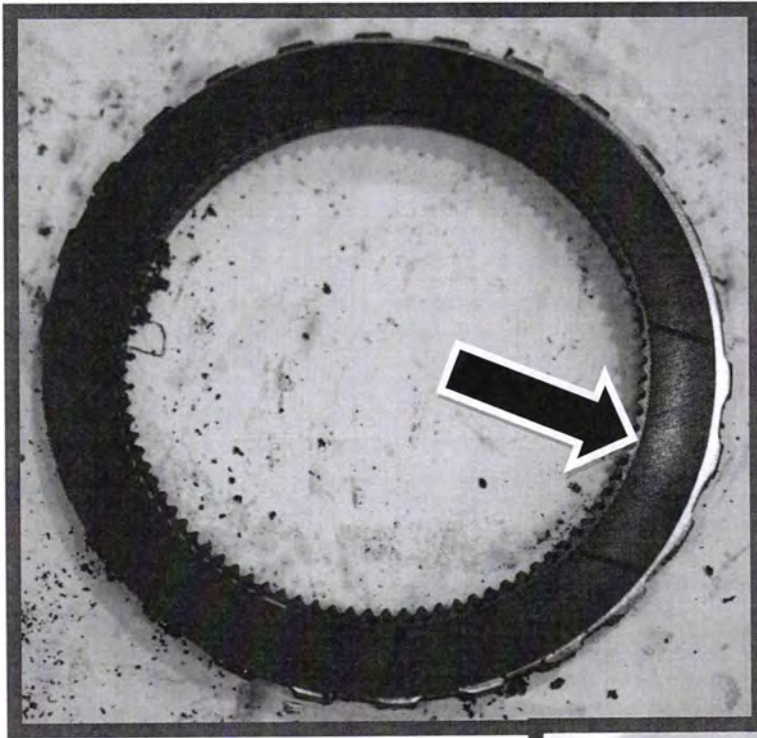
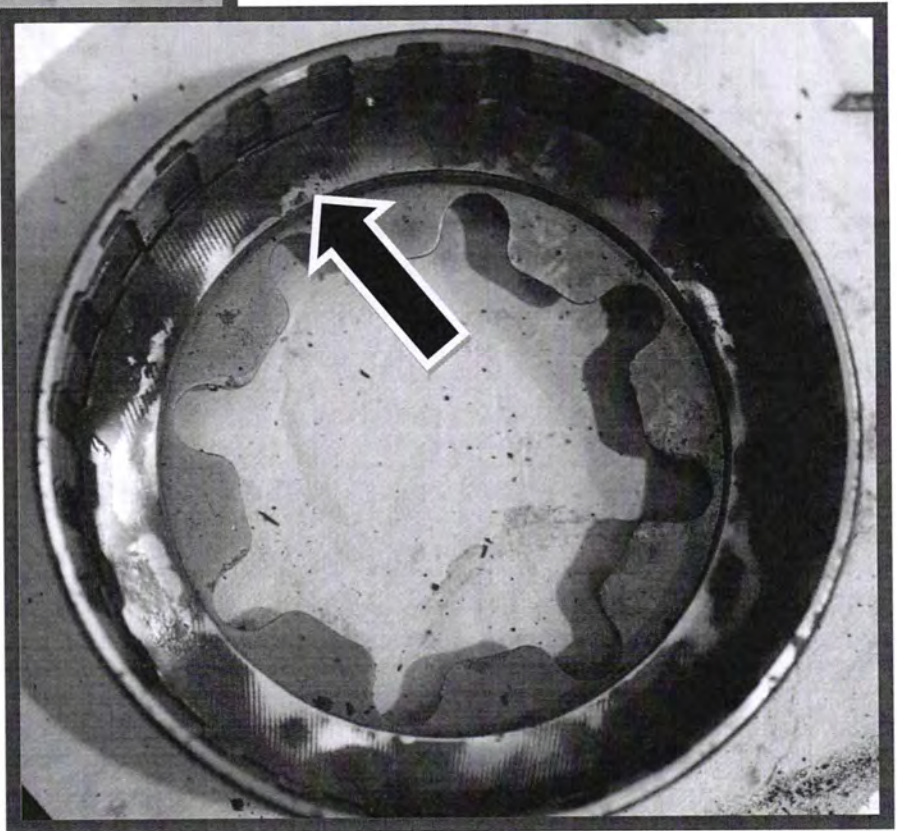
**Images No.11a & 11b.** These photographs depict two of the Forward Clutch friction discs removed from the E4OD/4R100 automatic transmission of the involved 2001 Ford Excursion stretch limousine. The Black Arrows denote the comparison of common friction material of a friction disc (Top Photo), to that of a friction disc of which the friction material has delaminated and overheated. This condition is consistent with the lack of proper vehicle maintenance.

*The disassembly and analyses of the components of the E4OD/4R100 automatic transmission removed from the involved 2001 Ford Excursion stretch limousine revealed evidence of the lack of proper maintenance to the concerning degree of notable transmission slippage when accelerating the vehicle from a stopped position. This condition would have been obvious to anyone who drove the vehicle, or experienced the vehicle accelerating from a stop.*

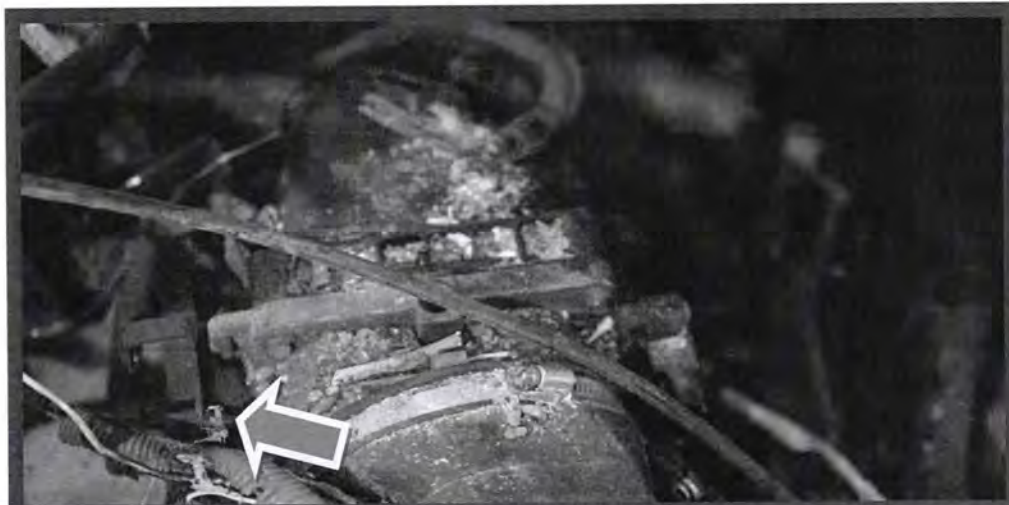
**Image No.12.** This photograph depicts the Throttle Body of the involved 2001 Ford Excursion stretch limousine prior to removal for examination. The Blue Arrow denotes the Throttle Plate linkage, which is at a position of partially opened Throttle Plates. This was the direct result of the violent impact forces, which resulted in notable structural frame deformation; displacement of the engine/transmission assembly; and firewall deformation, thus retracting the throttle cable. Once throttle cable tension was released, the Throttle Plates of the Throttle Body firmly returned to the idle position.

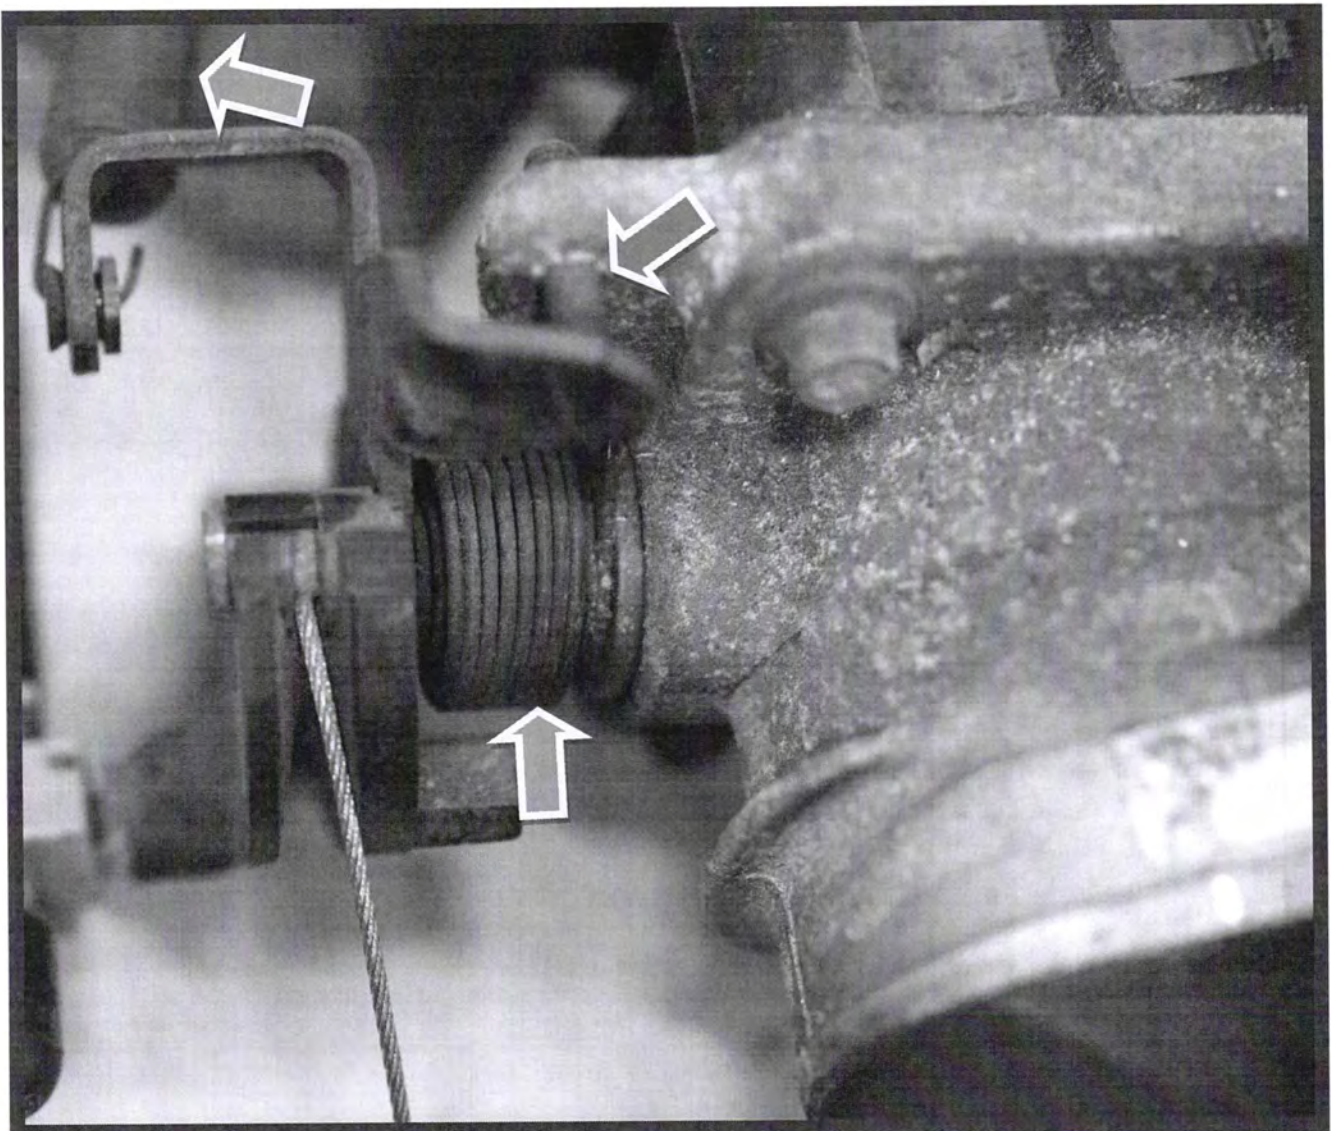
**Image No.13.** This photograph depicts the Throttle Body of the involved 2001 Ford Excursion stretch limousine during subsequent examination/analysis. The Blue Arrow denotes the Throttle Plate linkage, which is firmly at a position of closed Throttle Plates. No binding of Throttle Plate transition was present. The Orange Arrows denote the multiple intact and functional Throttle Plate Return Springs, mandated by applicable Federal Motor Vehicle Safety Standards. Digital Force Gauge testing revealed positive spring return to idle force of 7.733 lbs.

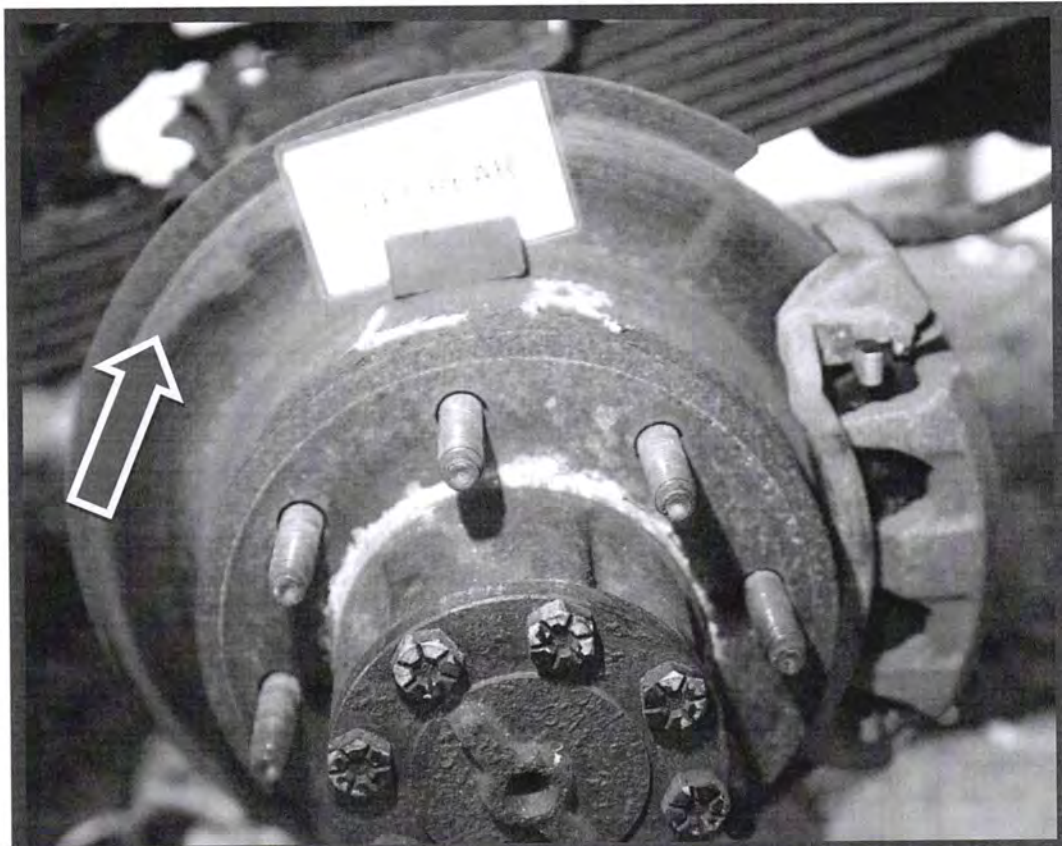
**Image No.14.** This photograph depicts the left rear disc brake components of the involved 2001 Ford Excursion stretch limousine prior to removal from the vehicle. Note the outer disc brake rotor swept area corrosion, which was a pre-existing condition (Red Arrow).

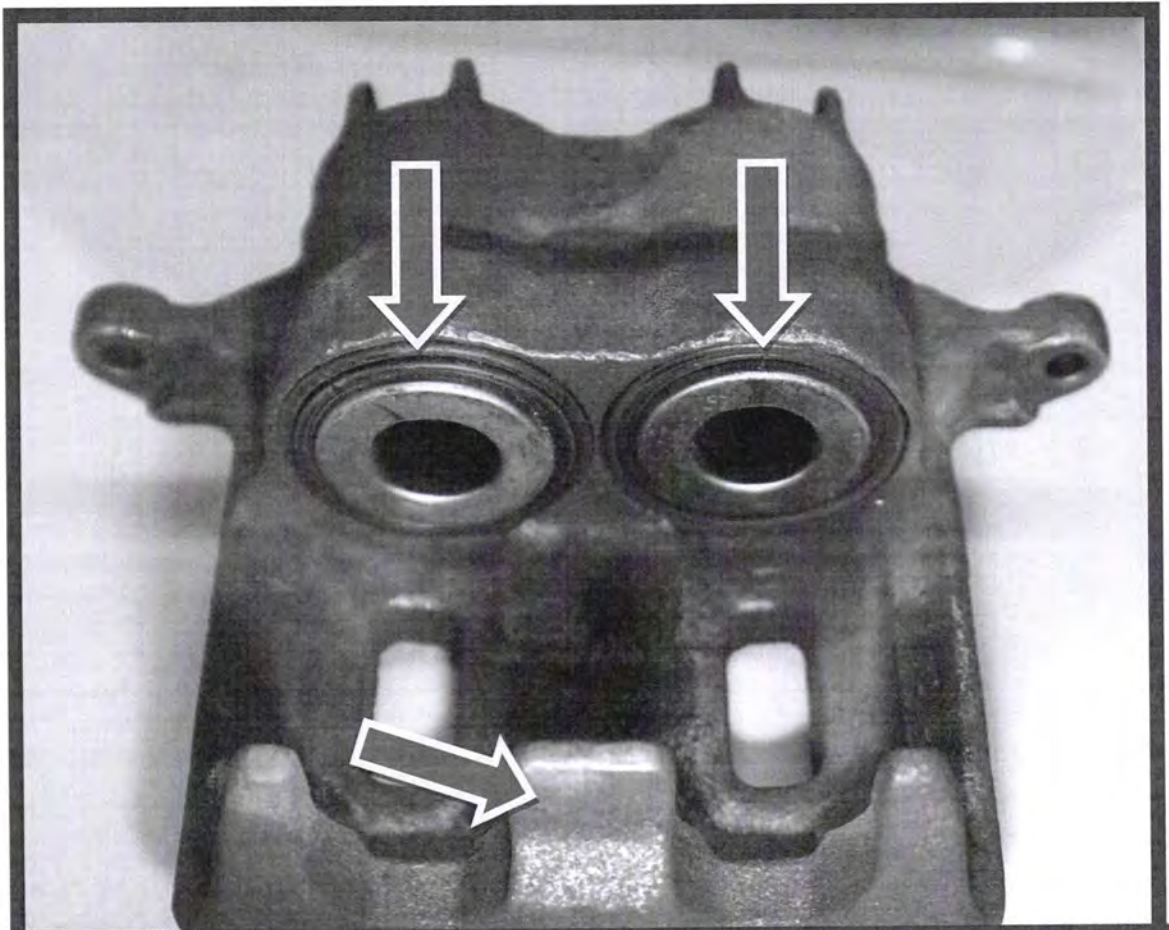
Disc Brake Caliper, Left Rear – The left rear disc brake caliper of the 2001 Ford Excursion stretch limousine exhibited slight casting oxidation, with both piston surfaces presenting insignificant exposure. This condition was consistent with the Repair Order of Mavis Discount Tire dated May 11, 2018<sup>11</sup>, which indicated replacement of the Brake Caliper, Brake Hose, and Brake Pads. Brake dust presence was nearly nonexistent.

**Image No.15.** This photograph depicts the left rear disc brake caliper of the involved 2001 Ford Excursion stretch limousine during the period of individual component analysis. Note the state of the cast caliper body, as well as that of the two caliper pistons and piston seals (Blue Arrows). The condition of the component was consistent with that of replacement per the Repair Order of Mavis Discount Tire, dated May 11, 2018.

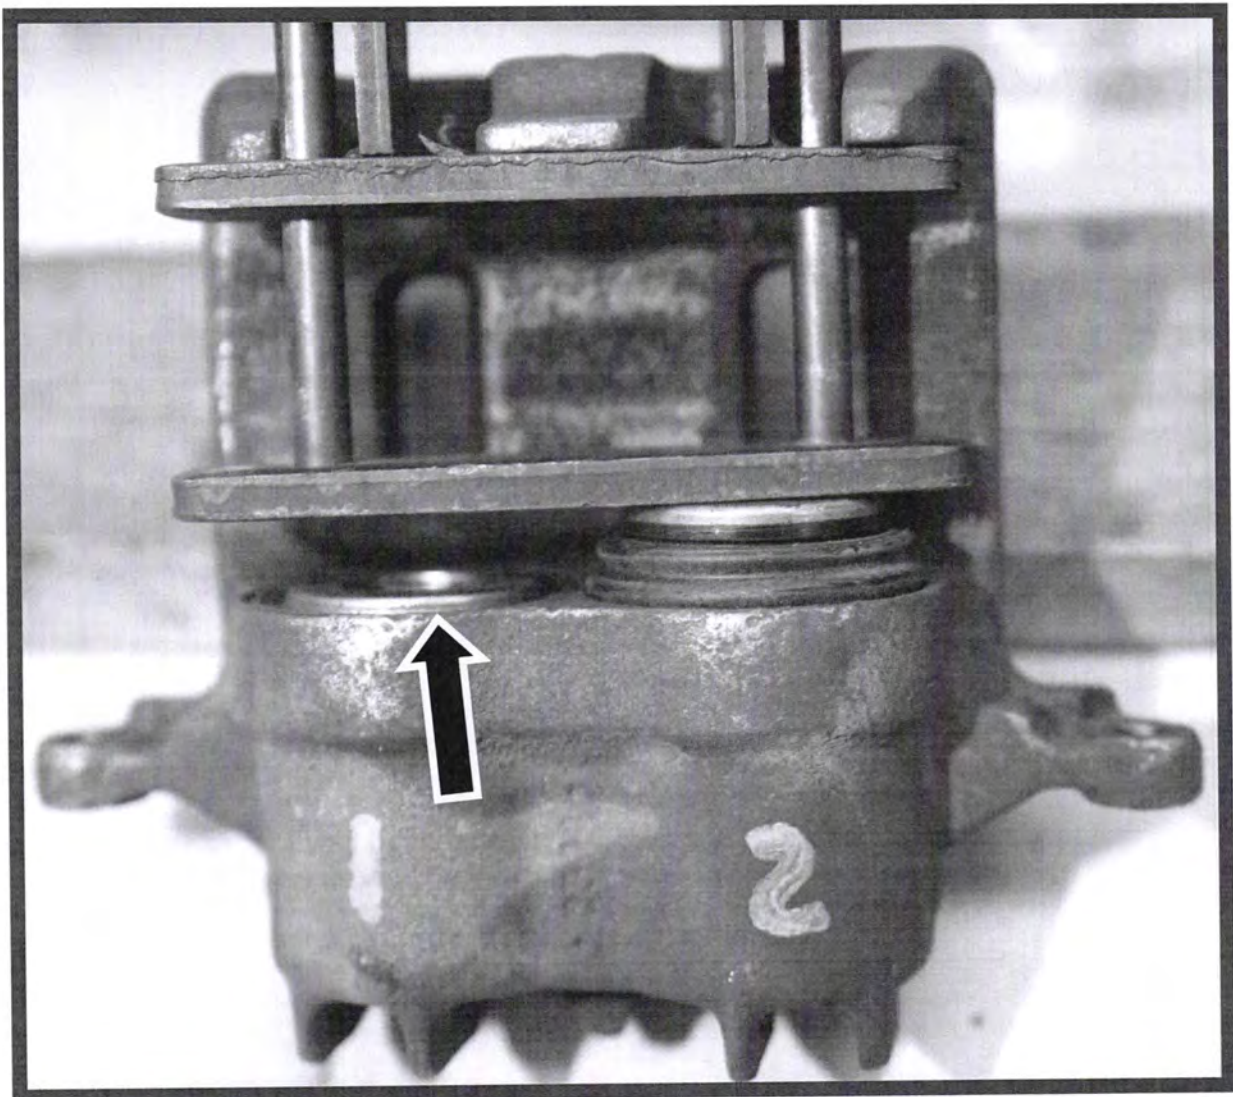
**Image No.16.** This photograph further depicts the left rear disc brake caliper of the involved 2001 Ford Excursion stretch limousine during the period of individual component analysis. Disassembly procedures revealed that the leading disc brake caliper phenolic piston, designated as Number "1", exhibited binding/partial seizure within its bore, noted within the image by comparing the height of the two pistons in the caliper housing (Black Arrow). This condition would result in reduced brake force at the left rear wheel location of the vehicle during stopping maneuvers.

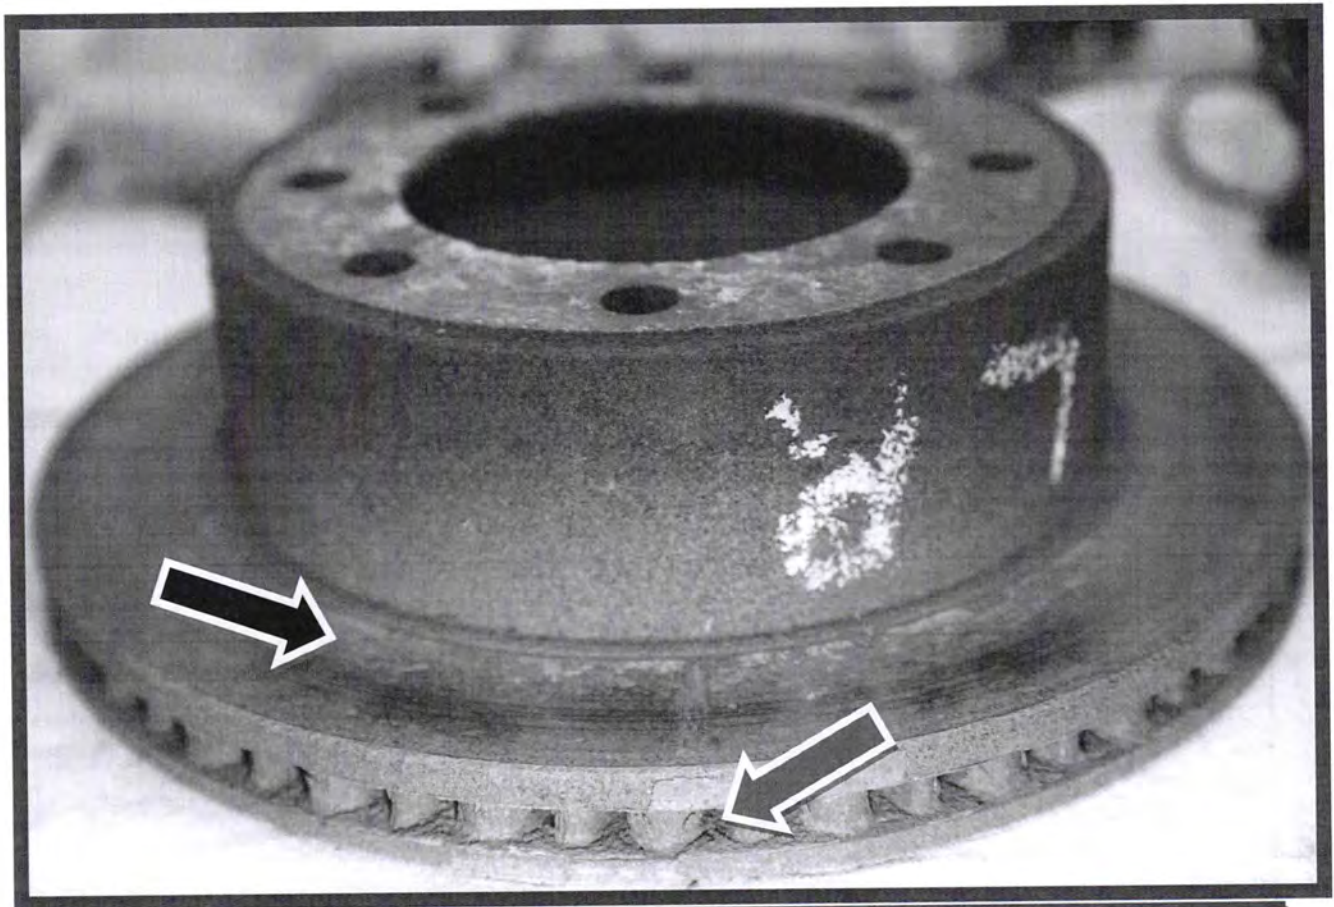
- ✓ No thermal distress noted.
- ✓ Minimal brake dust presence.
- ✓ Outer swept area exhibited corrosion, oxidation, pitting, and scoring.
- ✓ Inner swept area exhibited prominent scoring/excessive wear and delamination, consistent with continual prior metal-to-metal disc brake pad contact from neglect of brake system maintenance; additionally, inner swept area exhibited prevalent corrosion consistent with prolonged absence of braking effort at left rear wheel location.
- ✓ Disc brake rotor was not machined/replaced during brake service conducted by Mavis Discount Tire on May 11, 2018.
- ✓ Minimum measured left rear disc brake rotor thickness = 1.124". Original disc brake rotor thickness = 1.185". Minimum disc brake rotor thickness specification = 1.10". Minimum disc brake rotor thickness to machine rotor specification = 1.12".

**Image No.17.** This photograph depicts the left rear disc brake rotor of the involved 2001 Ford Excursion stretch limousine during the period of individual component analysis. Note the heavy corrosion/scaling (Red Arrow) present at the vent vane areas, resulting in a reduction in the effectiveness of the disc brake rotor cooling design. Also note the presence of corrosion at the outer swept area (Black Arrow) -- the area of contact by the outer disc brake pad friction material.

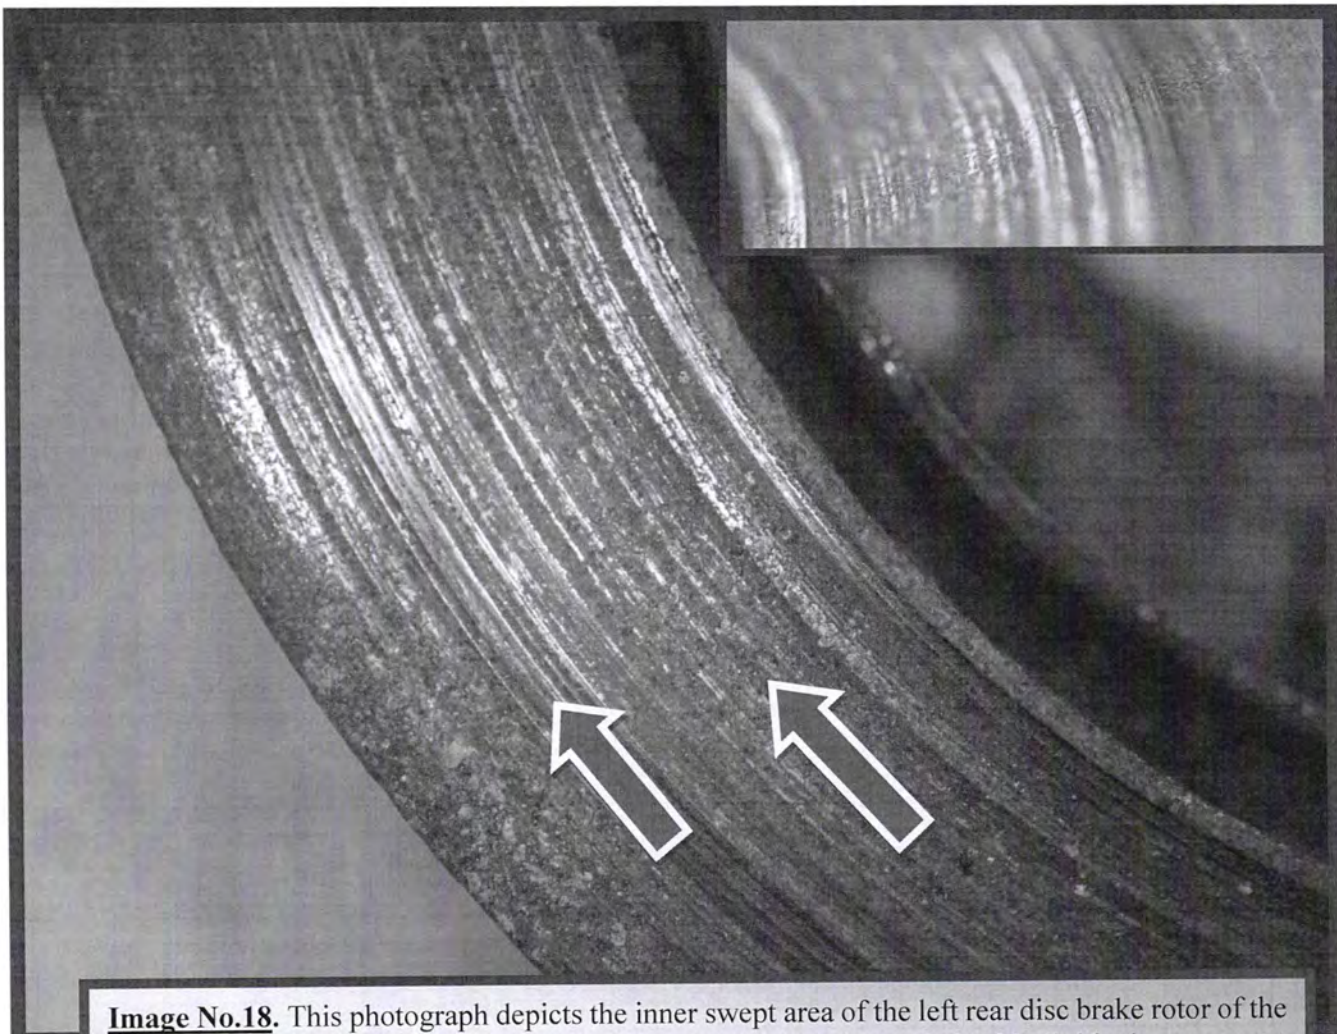
**Image No.18.** This photograph depicts the inner swept area of the left rear disc brake rotor of the involved 2001 Ford Excursion stretch limousine during the period of individual component analysis. Note the heavy corrosion/scaling and prominent scoring (grooving) present (Red Arrows), consistent with 1) the prolonged operation of vehicle with grossly deteriorated inner brake pad friction material; and 2) ineffective brake effort. Insert photograph depicts the extent of the corrosion/scoring. Photograph below denotes comparison of rotor thickness to that of new rotor.

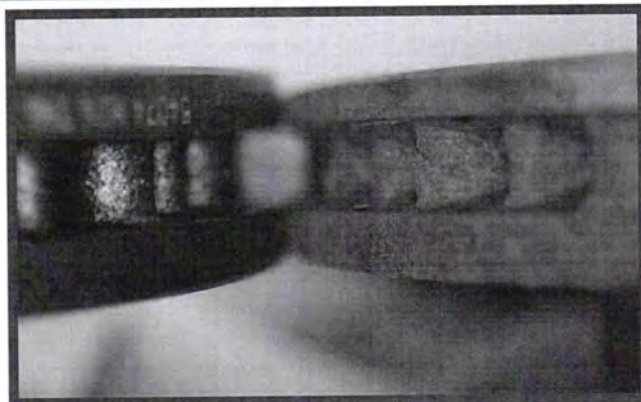
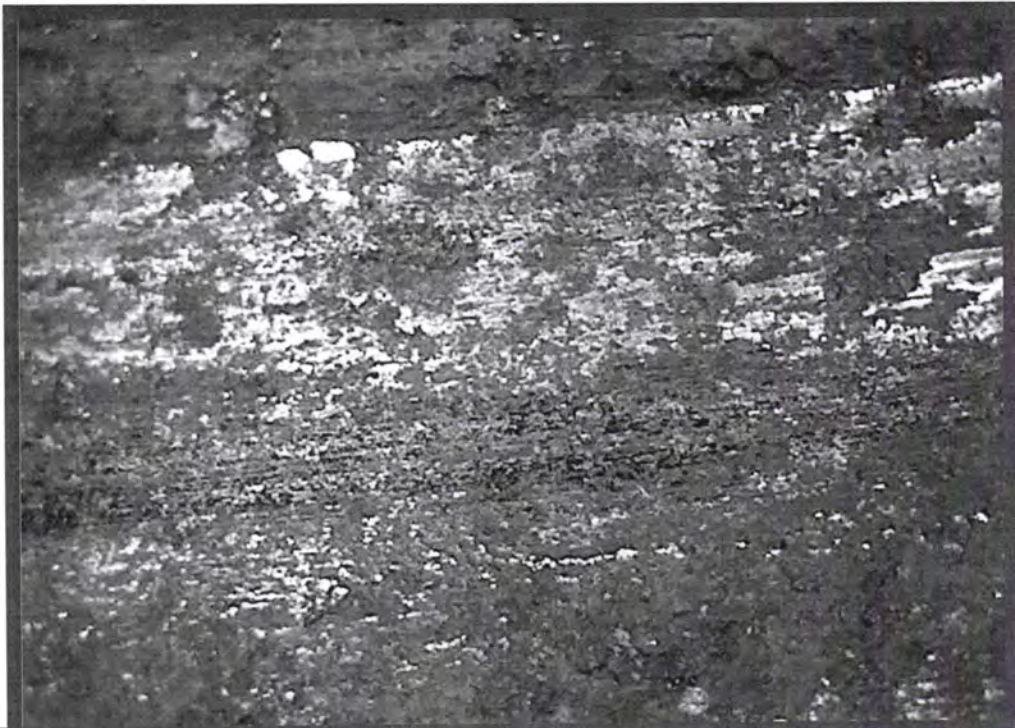
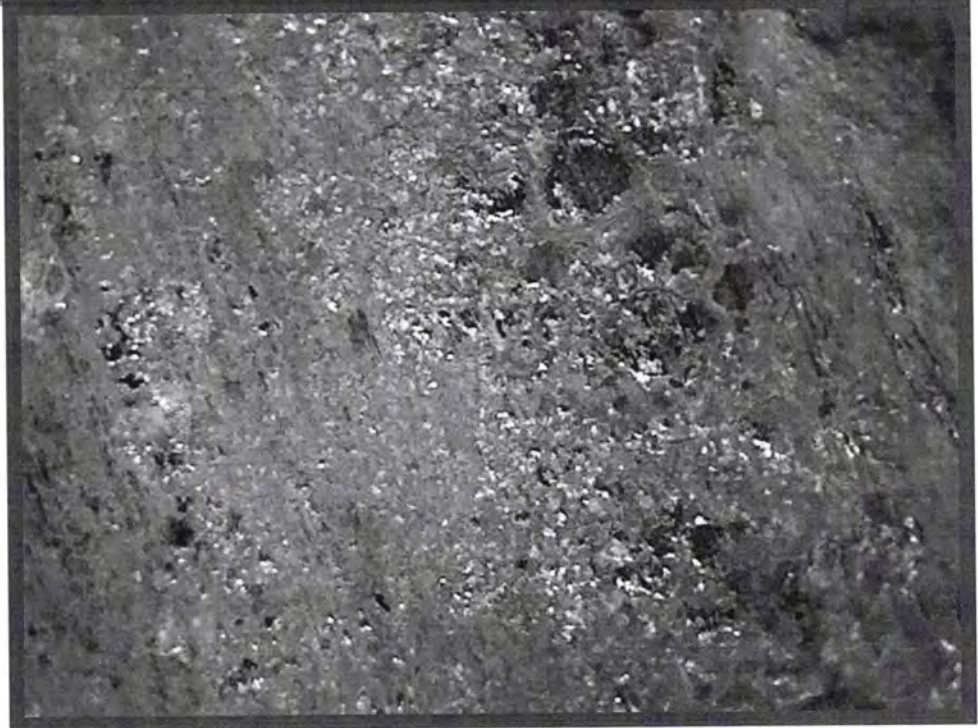
**Images No.19a & 19b.** These digital microscope photographs depict the critical state of corrosion/delamination present at the inner swept area of the left rear disc brake rotor of the involved 2001 Ford Excursion stretch limousine (above photograph), as well as the oxidation/corrosion present at the outer disk brake rotor swept area (bottom photograph).
